# FACT SHEET: INFRA-RED CAMERAS

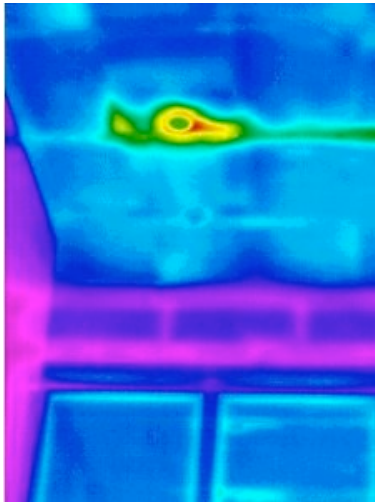
The infra-red image on the left shows the window (bottom part of the image) and ceiling of a recently built house. The insulation installers were not Right House approved. The image shows that the installers failed to fit the insulation tightly against the CA rated downlights. Furthermore they left a clearly visible gap, as shown in the image on the right, between two insulation sections on the right of the downlight.

Our cameras are sensitive enough to also pick up the increased heat losses through the timber framing above the windows (pink areas). This effect is known as "thermal bridging". Our consultants are familiar with a number of building techniques to avoid these unnecessary heatlosses through this thermal bridging.

The home owners subsequently asked Right House to fix the problem.

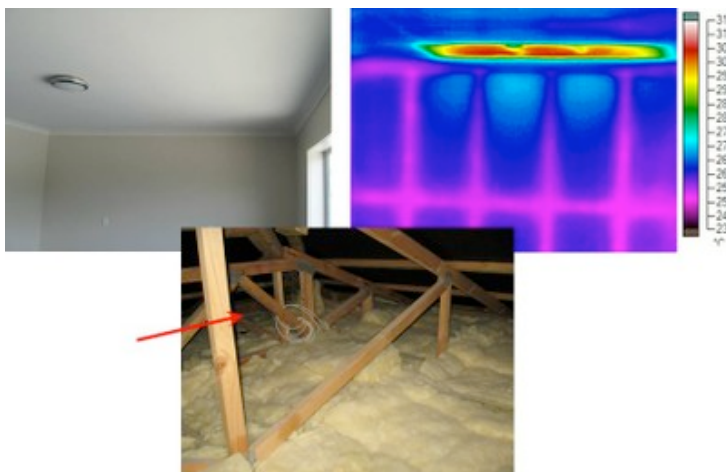
The following images show another recently built house. The owners had especially specified increased insulation in the ceiling. However, an inspection by a Right House consultant showed three large "hot spots" on the infra-red image of the bedroom ceiling. (The images were taken on a sunny summer afternoon when the roofspace was very warm.)

From the manhole it was difficult to see that the insulation installers had missed three whole sections of ceiling insulation (red arrow). Without the infra-red camera inspection the mistake would probably have gone unnoticed and the home owner would have paid for the installers' carelessness through higher heating bills in winter and increased cooling costs in summer.
